TCS No. 1406/64-KH IB No. 105/64 27 February 1964 Copy

: Rail and Road Study Yen-hu to Sino-Soviet Border

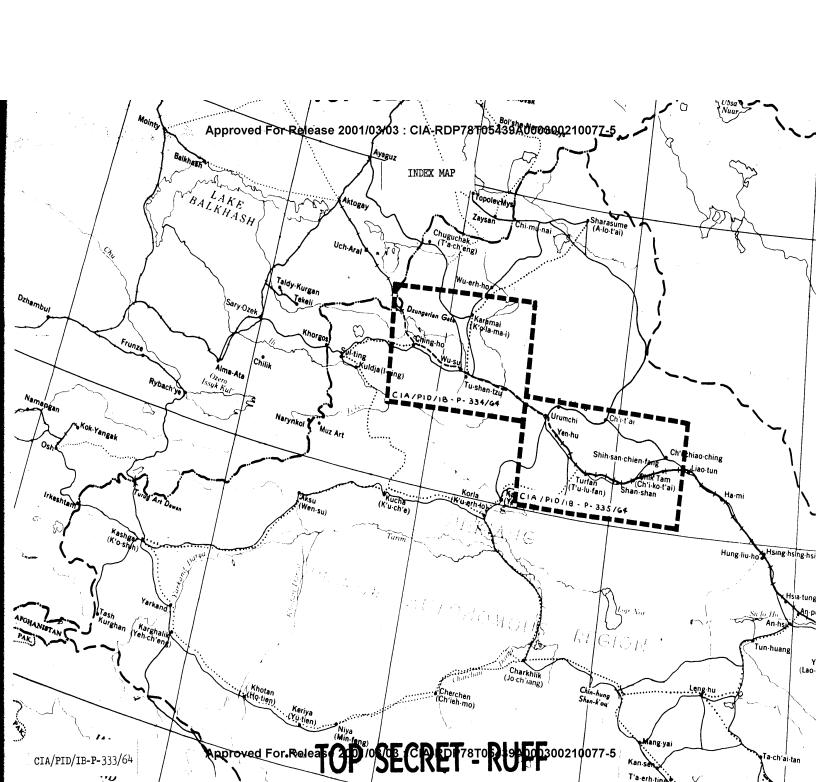
- 1. See annotated photo, Enclosure No. 1, for details on this area. This is the end of the Russian 5'0" gage net. It is a branch of NIS Line No. 26, and is operational to this point.

- See annotated photo 1.
- 3. Ground scarring in this area indicates rail line construction is in its earliest stages.
- 4. No construction activity observed in this area.

- 5. Ground scarring in this area indicates rail line construction is in earliest stages.
- 6. No construction activity observed in this area.
- 7. Rail line in early stages of consteuction in this area, breaks in line, partial grading, lack of bridging.

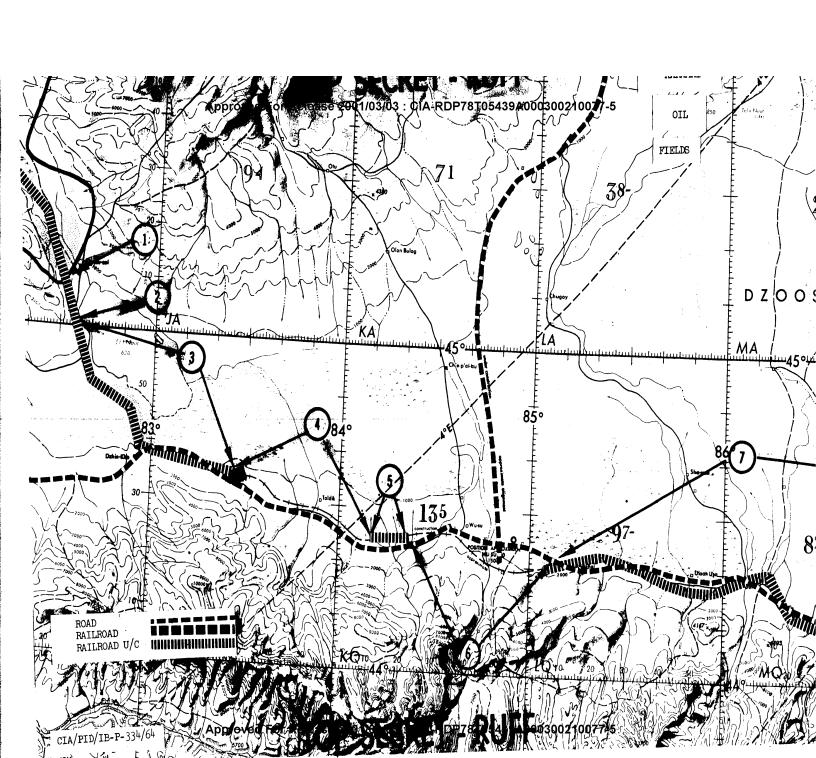
- 8. See annotated photo, enclosure No. 2.
- 9. See annotated photo, enclosure No. 2.
- 10. See annotated photo, enclosure No. 3.
- 11. Rail line from Urumchi to Fu-yuan (44° 00'N 89° 09'E) is under construction. Rail line is graded, however track structure is not discernable.

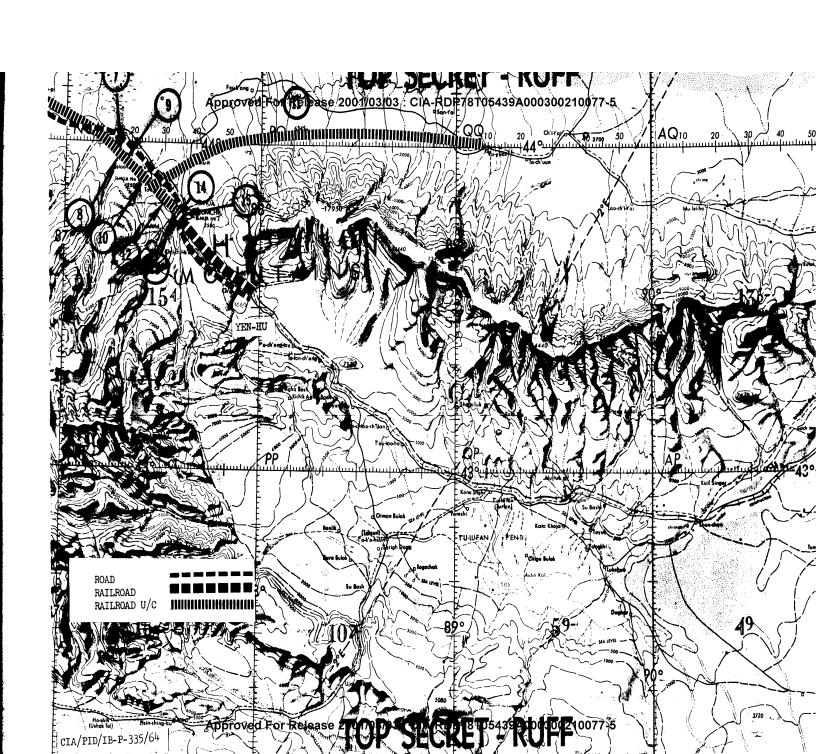
- 12. See annotated photo, enclosure No. 4.
- 13. See annotated photo, enclosure No. 4.
- 14. See annotated photo, enclosure No. 4.
- 15. Rail Line operational in this area.
